MANAGEMENT AND REHABILITATION OF THE SILVERMINES AREA

PHASE II REPORT: MANAGEMENT OPTIONS

DEPARTMENT OF MARINE AND NATURAL RESOURCES

**SRK Consulting
Windsor Court
1-3 Windsor Place
Cardiff
CF10 3BX**

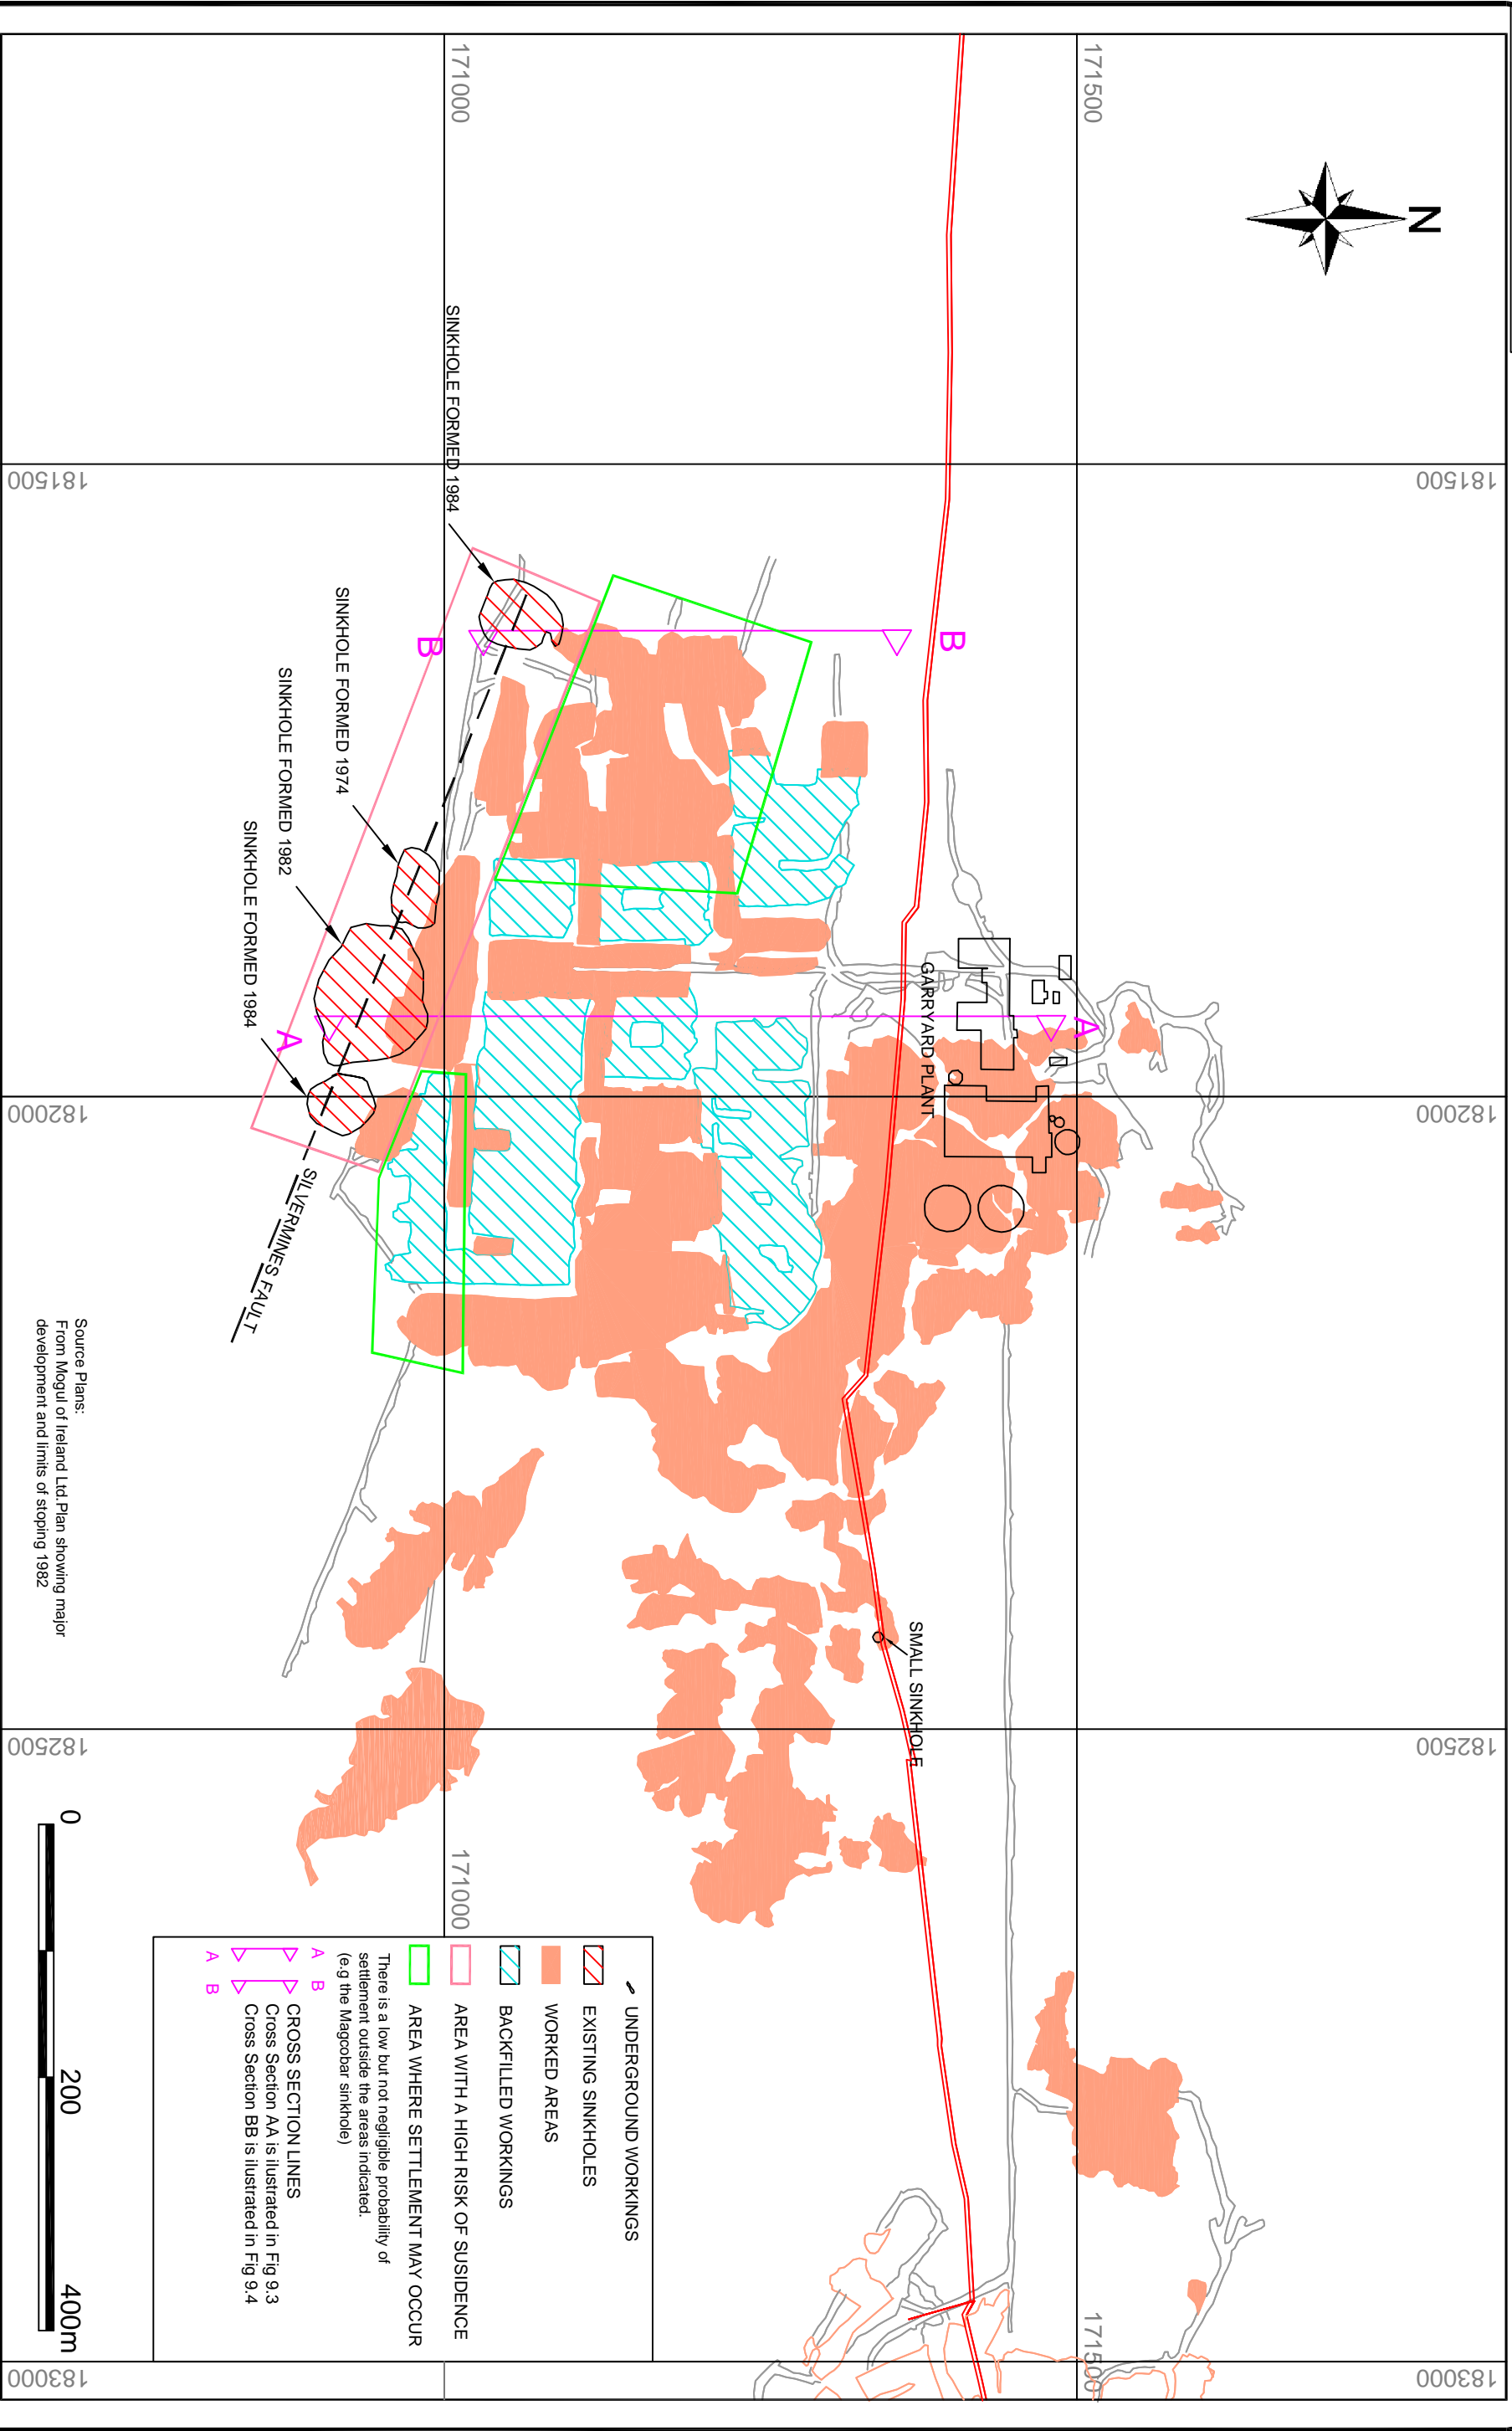
A surface subsidence feature developed in 1974 (Figure 9.2)²⁴⁸, and the 1W6-S stope caved through to surface during April 1977. This stope mined a steep area of orebody adjacent to the Silvermines fault. It is believed that the large size of the stope, combined with the steeply dipping strata in the hangingwall and the poor ground conditions adjacent to the fault, caused collapse of the stope roof. The collapse propagated to surface resulting in the development of a 50 m long by 17m wide depression. A similar subsidence feature developed to the east in 1982²⁰⁶, after mining of the adjacent 1E1-S stope had been completed. Failure of this stope resulted in the formation of a surface depression 75m long by 17m wide. The combined span of these stopes was in excess of 160 m. These subsidence features are still active. Figures 9.3 and 9.4 give schematic geological sections through the subsidence areas (see Figure 9.2 for section locations), showing the locations of the stopes. A number of stopes still remain open adjacent to the Silvermines Fault, albeit with spans somewhat smaller than the two stopes that had previously collapsed. It is probable that, with time, these stopes could also collapse, resulting in the development of surface subsidence. It is considered that the section of stoping along the Silvermines Fault between the existing sinkholes (Section 37300E to 38700E on the mine plans) has a high risk of the development of further subsidence. This area has already been fenced.

The previous collapses were probably aggravated by surface storage of water and future stream diversions will assist in limiting future collapse.
