MANAGEMENT AND REHABILITATION OF THE SILVERMINES AREA

PHASE II REPORT: MANAGEMENT OPTIONS

DEPARTMENT OF MARINE AND NATURAL RESOURCES

**SRK Consulting
Windsor Court
1-3 Windsor Place
Cardiff
CF10 3BX**

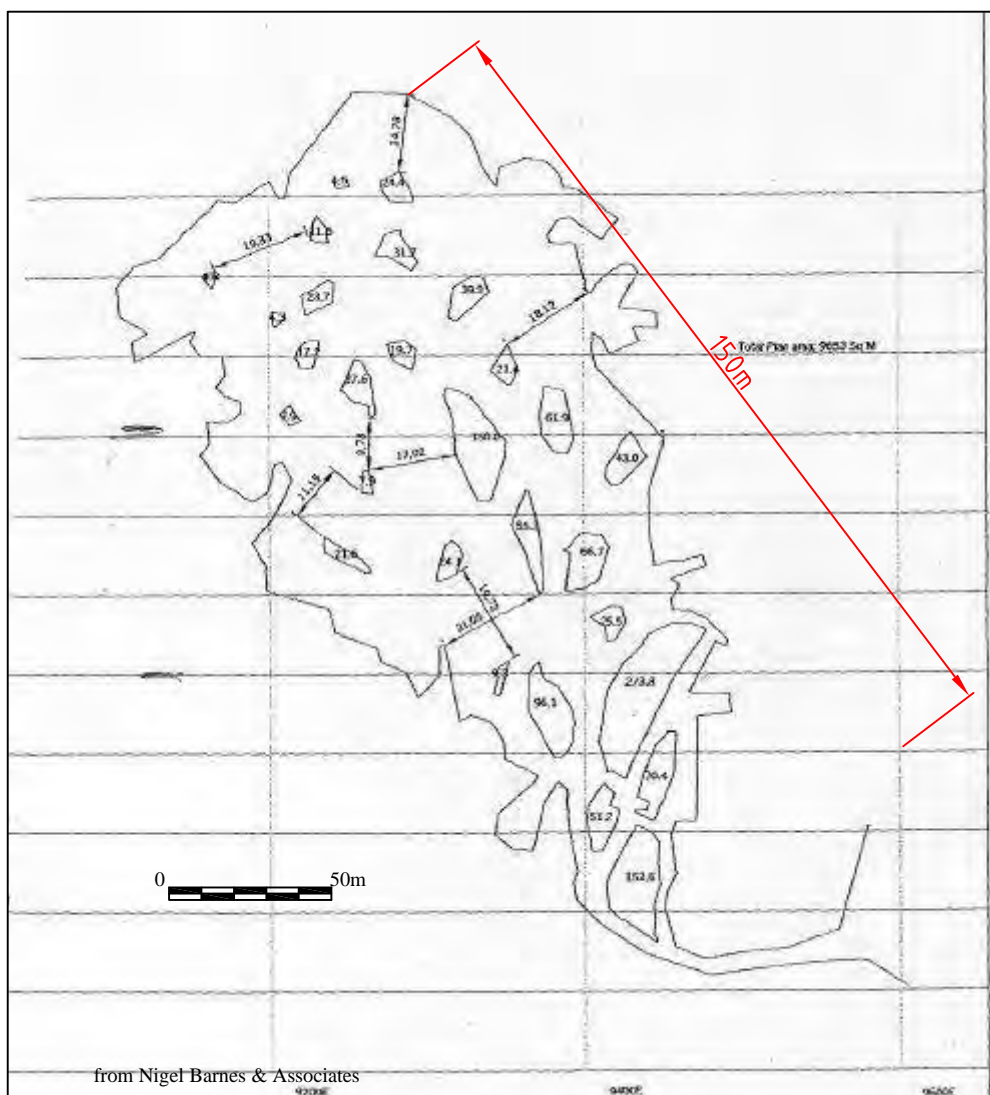
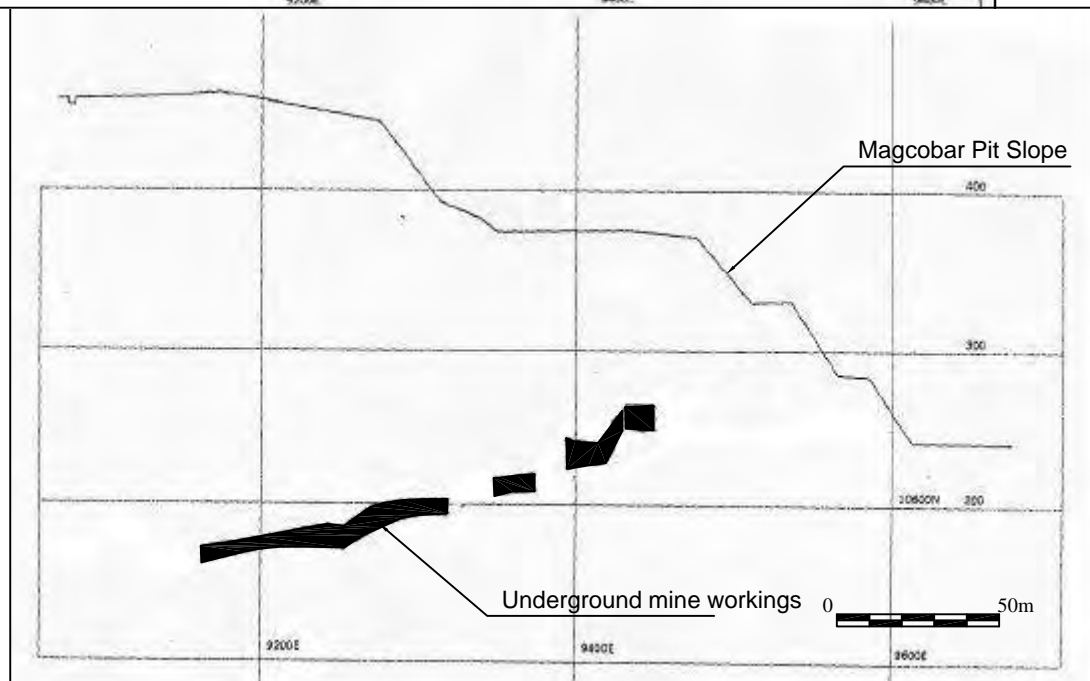
The Magcobar underground workings are an eastern extension to the Mogul workings. Little information was available for review, but Nigel Barnes and Associates had produced a plan and sections through the workings²⁵⁷. Figure 9.5 shows a plan of the workings and a typical section. The area of pillar support is small in relation to the area of extraction, and the stope width ranges from 15 to 26m. More than half the area of the workings is under the Magcobar pit slope, with the remainder beyond the crest. There has been no indication of mining subsidence.

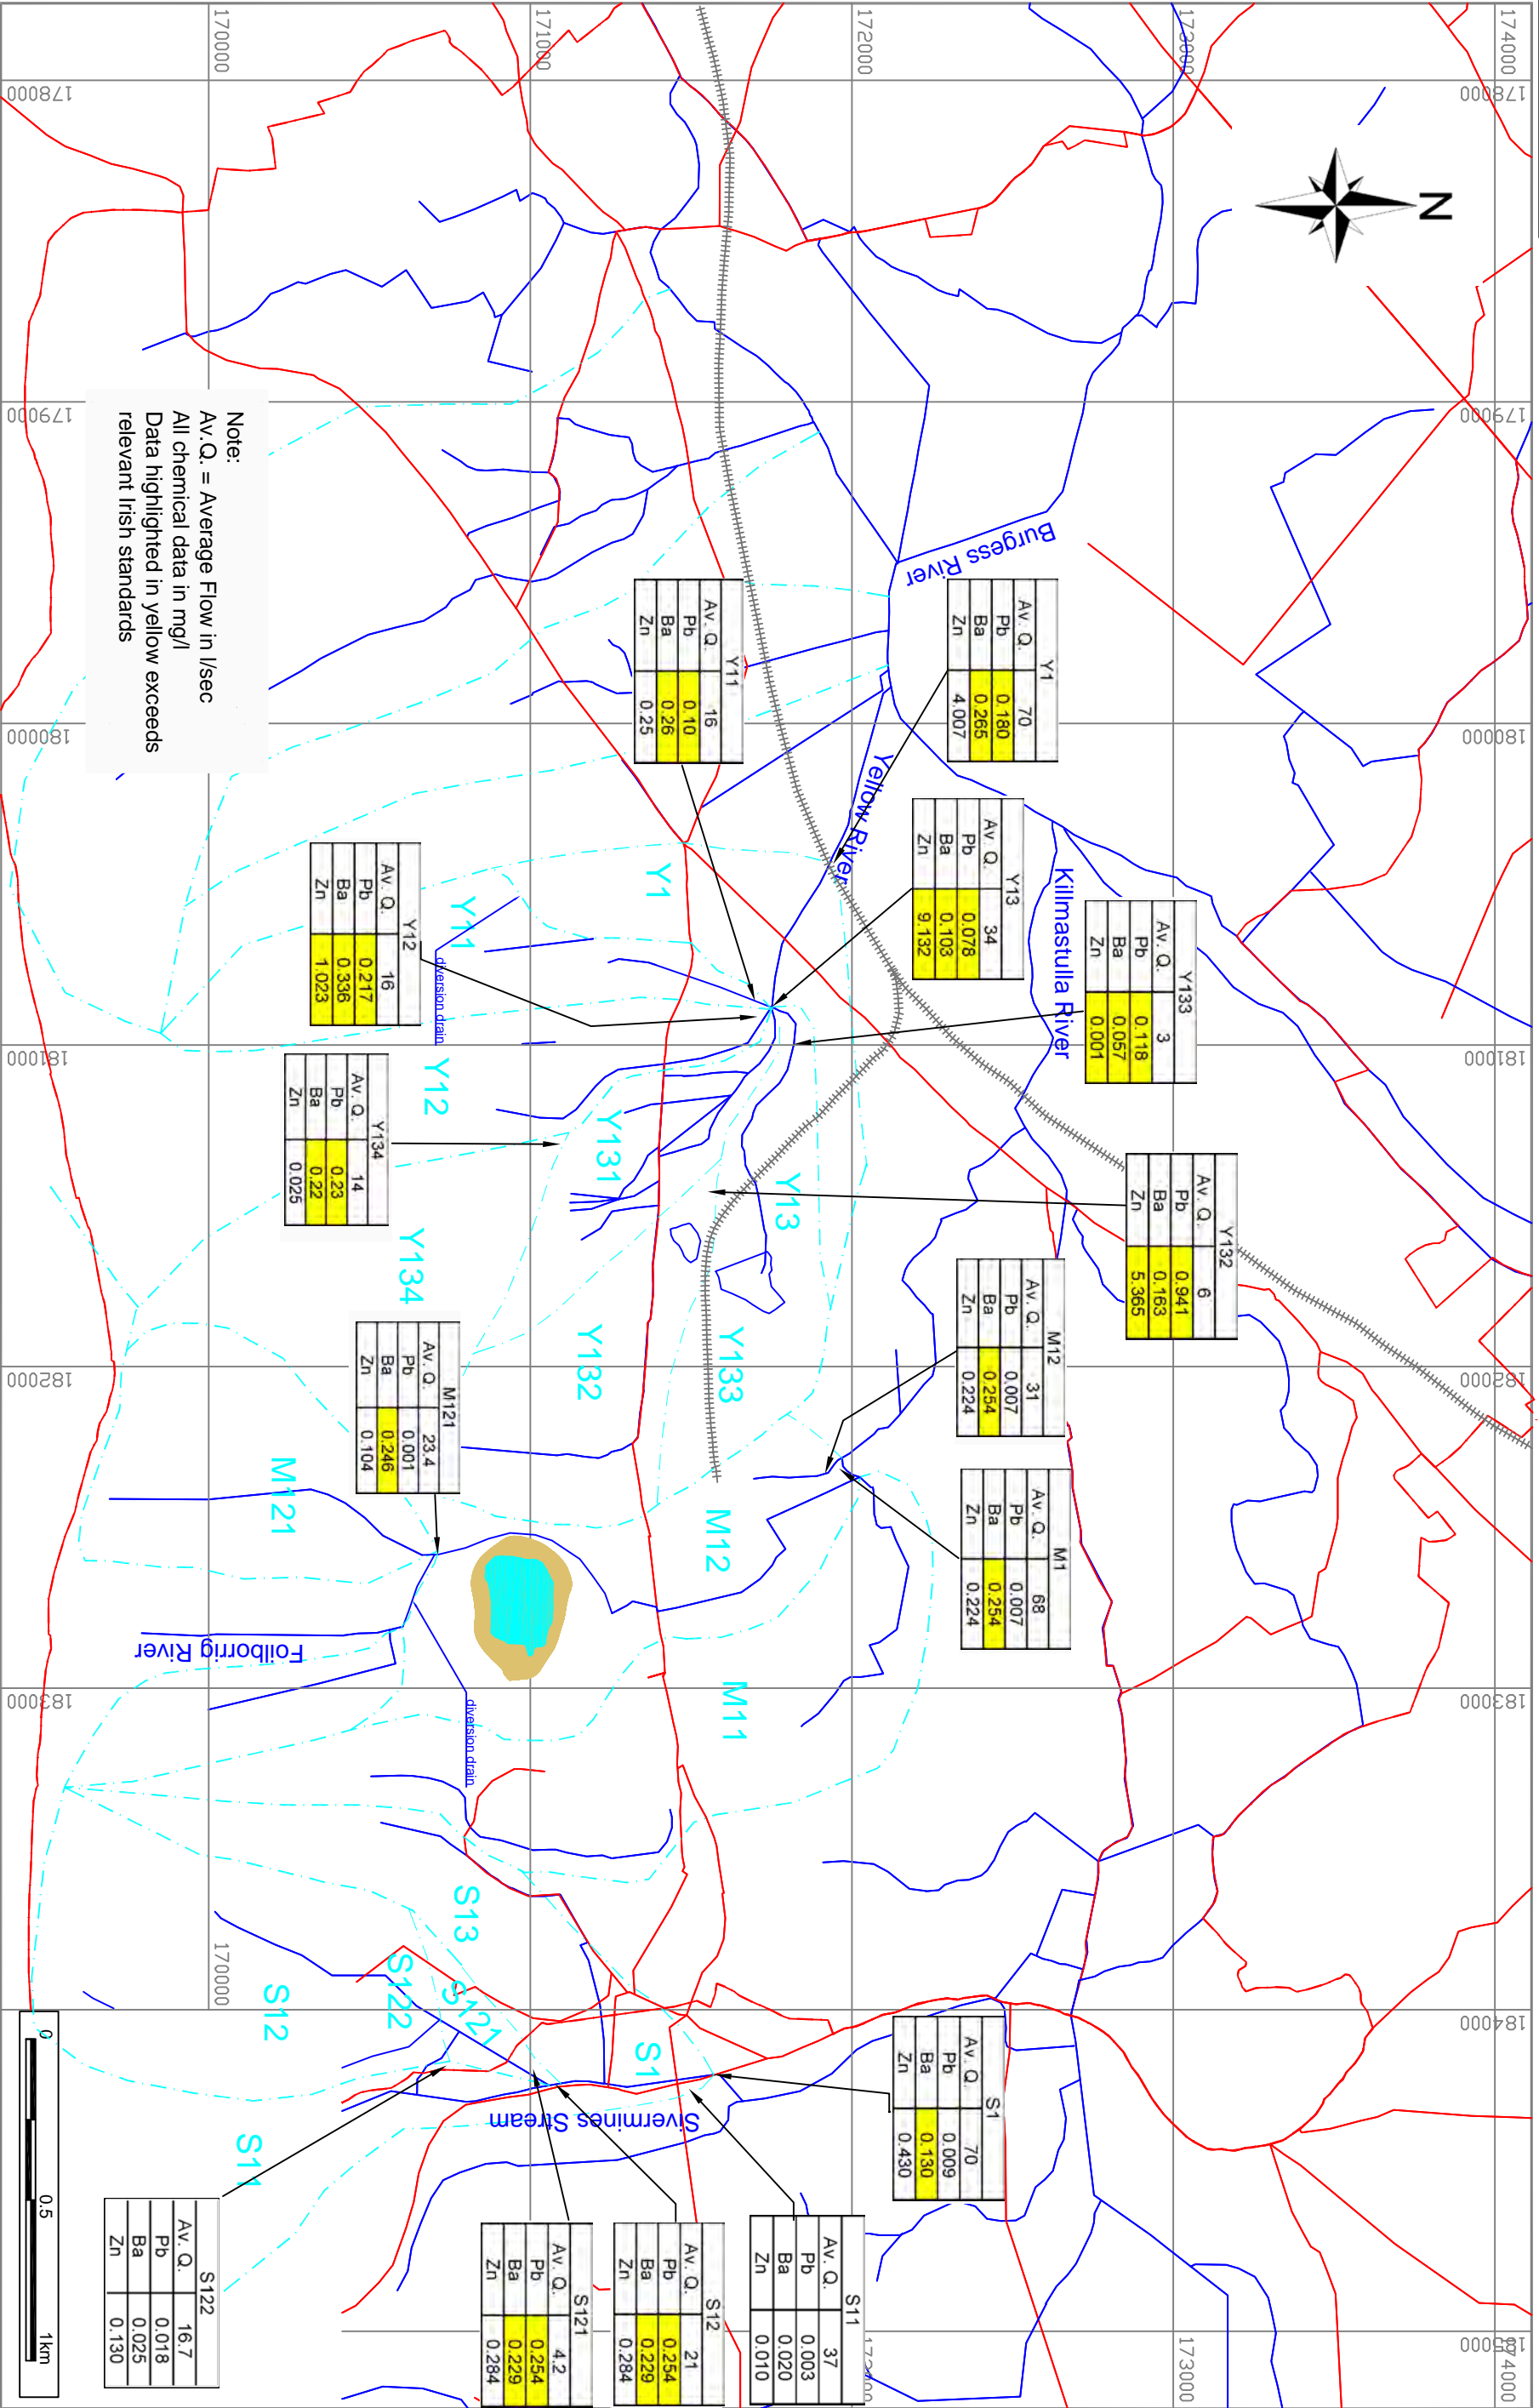
The principal sources of surface water metal contamination are the:

- waste rock dumps at Ballygown;
- old Stockpile area at Garryard;
- tailings lagoon at Garryard;
- the mineralisation at Magcobar; and
- parts of the Shallee tailings and Shallee Drum Dump.
