# MANAGEMENT AND REHABILITATION OF THE SILVERMINES AREA

### PHASE IV REPORT: CONCEPTUAL DESIGN

#### DEPARTMENT OF COMMUNICATIONS, MARINE AND NATURAL RESOURCES

U2465/2 November 2005

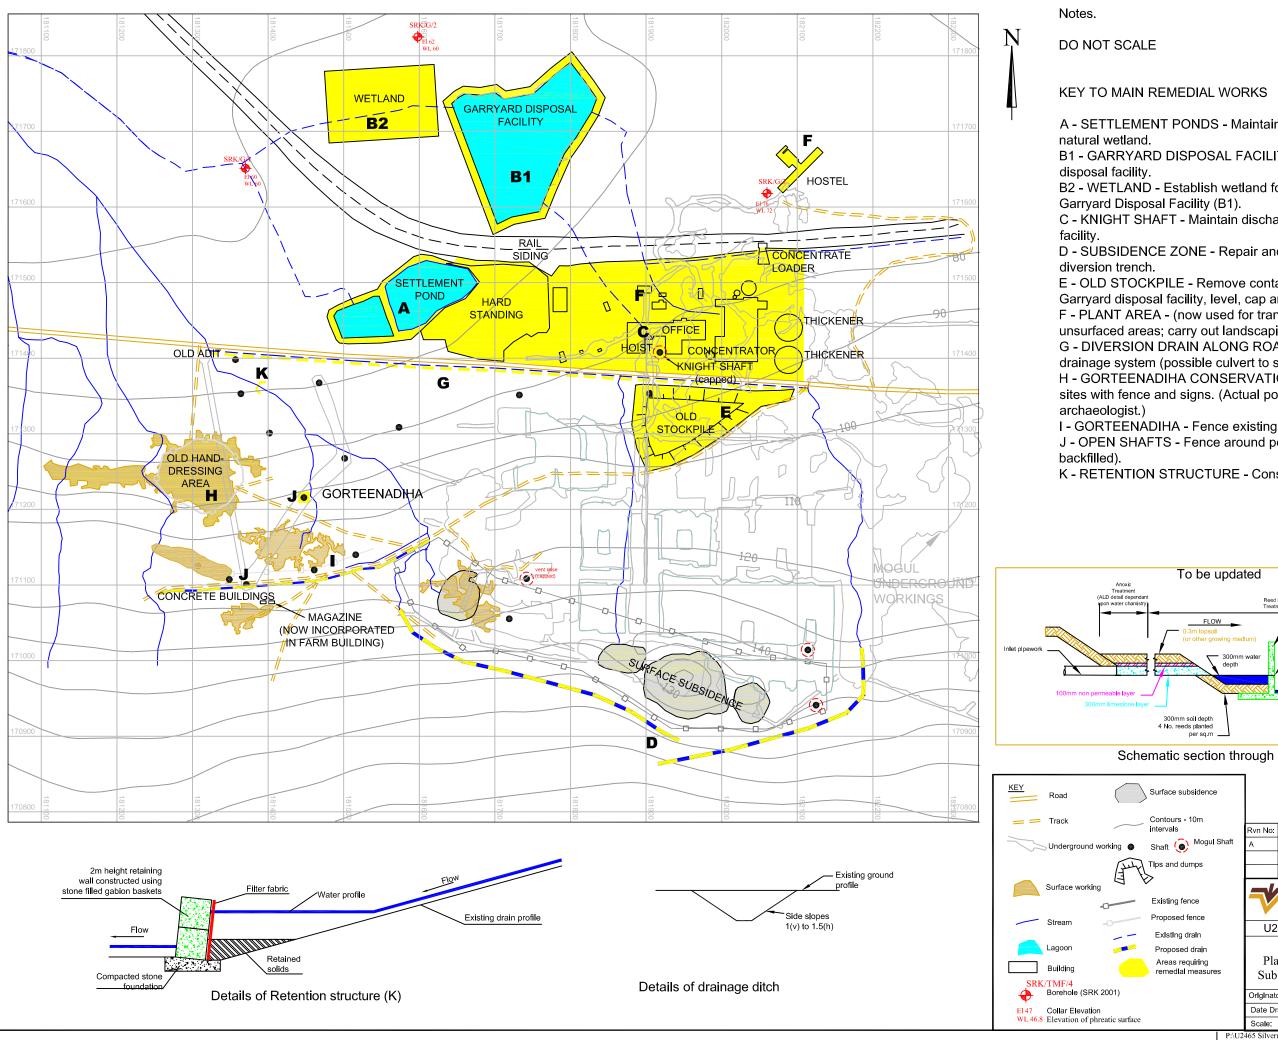
- A SETTLEMENT PONDS Maintain ponds and decant system as
- B1 GARRYARD DISPOSAL FACILITY Rehabilitate into engineered
- B2 WETLAND Establish wetland for treatment of streamflow from

- C KNIGHT SHAFT Maintain discharge flow to Garryard disposal
- D SUBSIDENCE ZONE Repair and maintain existing fence. Install
- E OLD STOCKPILE Remove contaminated dumped material to Garryard disposal facility, level, cap and re-vegetate.

- F PLANT AREA (now used for transport depot) Profile and cover unsurfaced areas; carry out landscaping works; remove hostel building.
- G DIVERSION DRAIN ALONG ROADSIDE Repair and maintain drainage system (possible culvert to settlement pond).

For the purpose of the present conceptual design of the disposal facility, assumptions have been made about the requirements for underlining and cover materials. . Figure 7.2 shows a conceptual design.
